FACILITY COMPLIANCE AUDIT REPORT

Division of Waste Management Solid Waste Section

Closed MSW Land Fill – Johns River
2500 Marsh Trail Rd.
Morganton, NC 28680

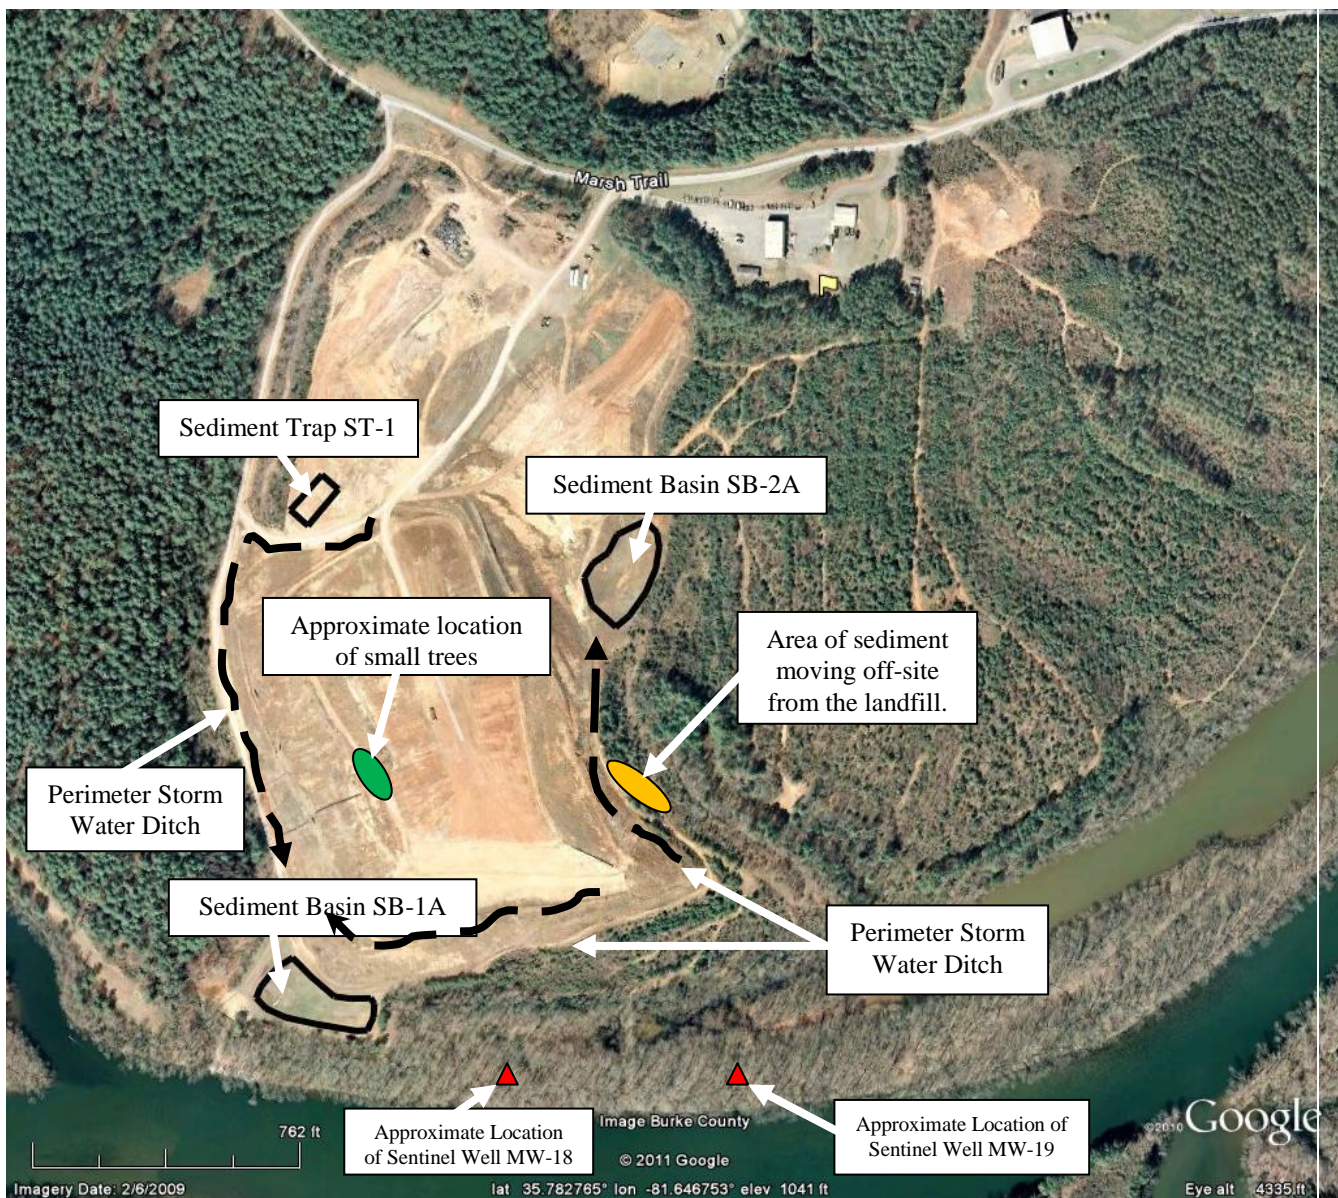
Map 2: Burke Co. GIS - Closed MSW LF 12-03- Sediment Ponds, Traps and Perimeter Storm Water Ditches

4. No leachate seeps were observed on any portions of the MSW landfill.
5. Work on the two new sediment basins (SB-1A & 2A) and one new sediment trap (ST-1) have been completed. (Map #2 and Photos #1, #2, and #3)

6. The perimeter storm water ditches on the west and south sides of the landfill have been improved with more “rip-rap.” (Photos #4 & #5)
7. The vast majority of trees and woody vegetation previously observed on the west and south faces have been removed. However, a several small trees and other woody vegetation were observed on the southern portion of the west slope in the area of the junction between the closed MSW and the active C&D landfills. (Map #2, and Photos #6) **These trees and woody vegetation must be removed.**

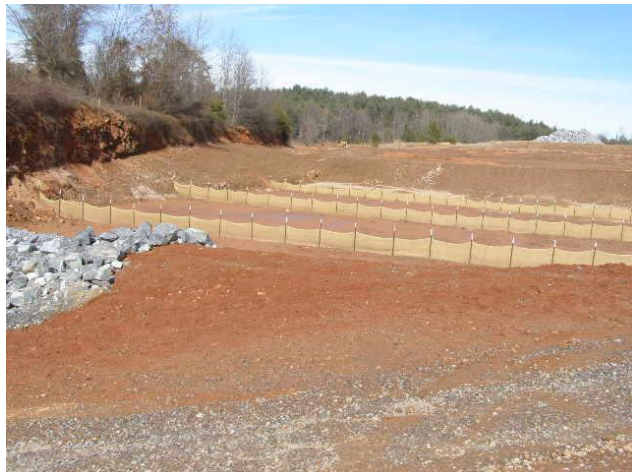
1. Looking (NE), at Sediment Trap ST-1. Rip-Rap on the left, lines the out-fall channel from the trap. (Taken 2/11/10 by Bill Wagner)

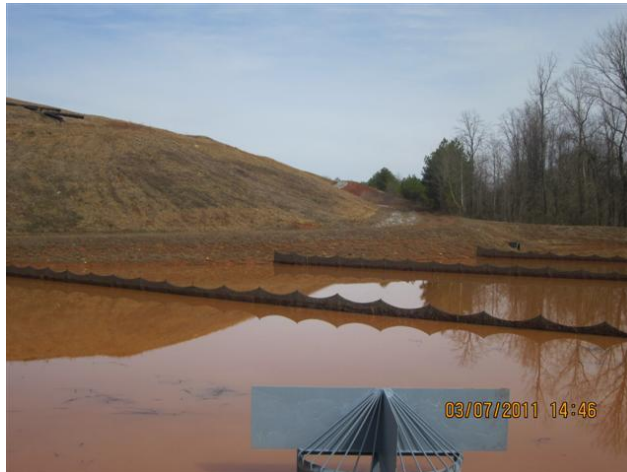
2. Looking (E) across Sediment Basin SB-1. The top of the over-flow intake is in the foreground.

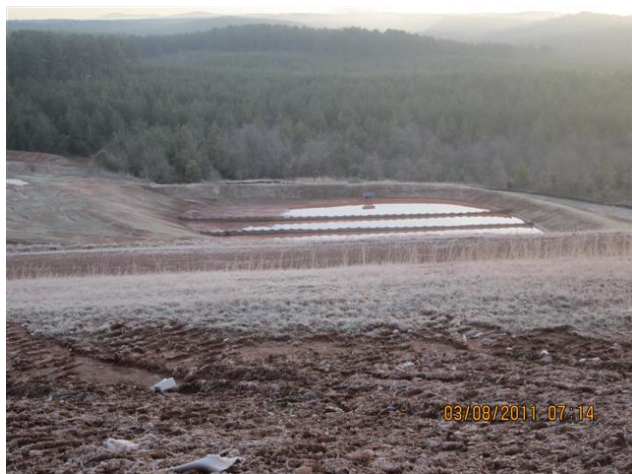
3. Looking (E) from the east side of the C&D landfill, at Sediment Basin SB-2A.

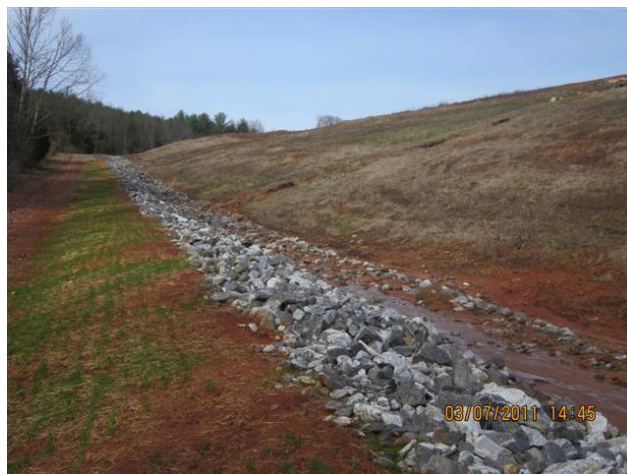
4. Looking (N) along the perimeter storm water ditch on the west side of the landfill.

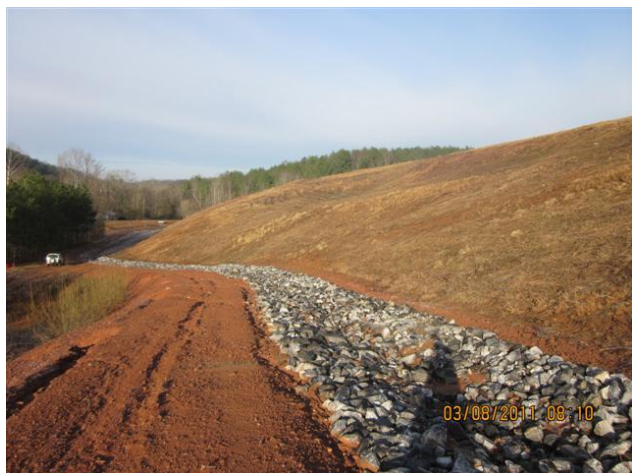
5. Looking (W) along the perimeter storm water ditch on the south side of the landfill.

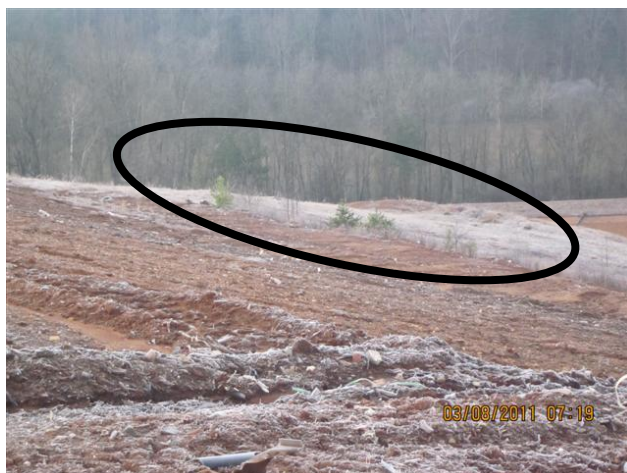
6. Looking (SW) from the top of the C&D landfill at a strip of small trees and woody vegetation in the area of the junction between the closed MSW and the active C&D landfills.

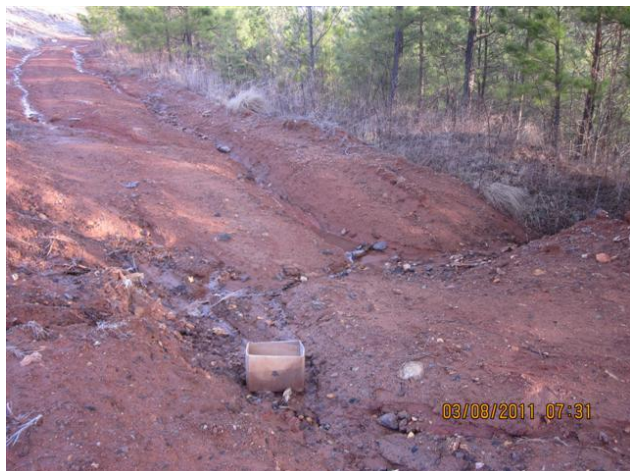
8. Due to the recent heavy rain, some sediment was observed moving off-site from the SE slopes of the landfill. (Photo #7 & #8) The perimeter road on the southeast and south sides of the landfill has become badly eroded. **The perimeter road needs to be re-graded.**

7. Looking (N) along the access road on the SE side of the landfill. Note the significant erosion that has caused sediment to move off-site. The road needs to be re-graded.

9. There is no effective perimeter ditch or other erosion control structures / devices on the east side of the landfill. This appears to have contributed to both the erosion of the perimeter road on this area as well as to the movement of sediment and silt off-site from the landfill. (Photos #7, #8, and #9). **15A NCAC 13B .1626(7)(a) states: "Adequate sediment control measures (structures or devices), shall be utilized to prevent silt from leaving the MSWLF facility." Please immediately implement whatever sediment control measures are necessary to prevent any further movement of sediment and silt from the facility.**

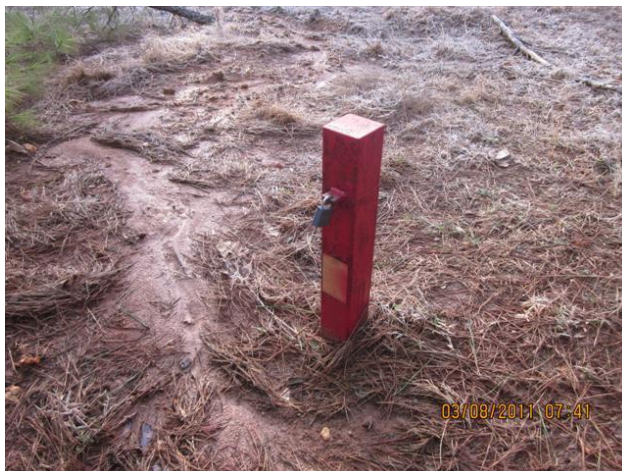
8. Looking (E) at sediment moving off-site from the SE slopes of the landfill. (Well is MW-13)

13. The landfill staff has painted the groundwater monitoring wells that are being monitored, red. (Photo #8).
14. Samples were collected from two surface water points SMP-5 and 6 (Map #1) from un-named streams that feed into the Catawba River.

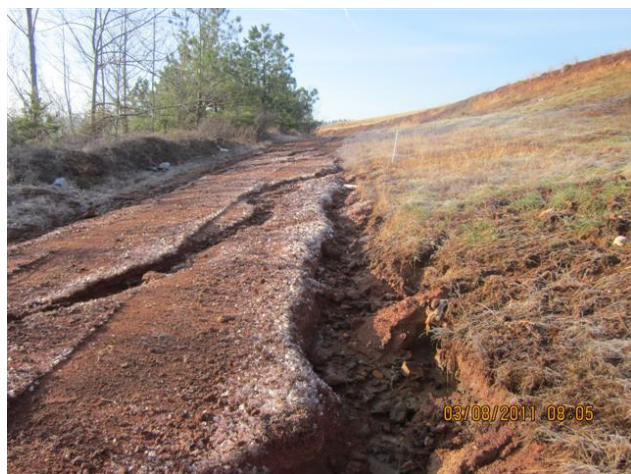
9. Looking (S) along the access road on the E side of the landfill. The road needs to be re-graded. (Note: that is no effective perimeter storm water ditch on this side of the landfill.)

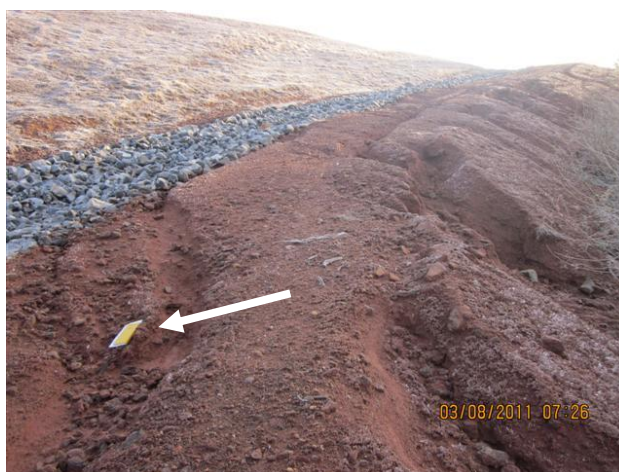
10. Looking E along the badly eroded access road on the south west side of the landfill. The rip-rap lined perimeter ditch is in the upper left. (Note the yellow field book (4 1/2" X 7 1/2") for scale.)

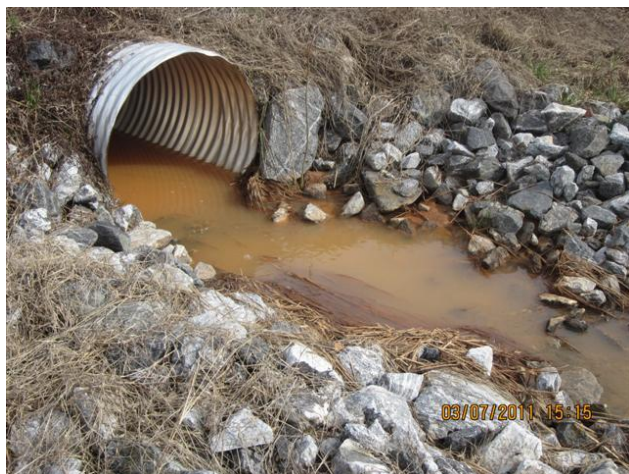
10. The out fall from Sediment Basin SB-1A, which goes directly into the Catawba River, was noticeably turbid on March 7, 2008 (Photos #11 & #12).

11. Sediment laden overflow from Sediment Basin SB-1 on 3/7/10.

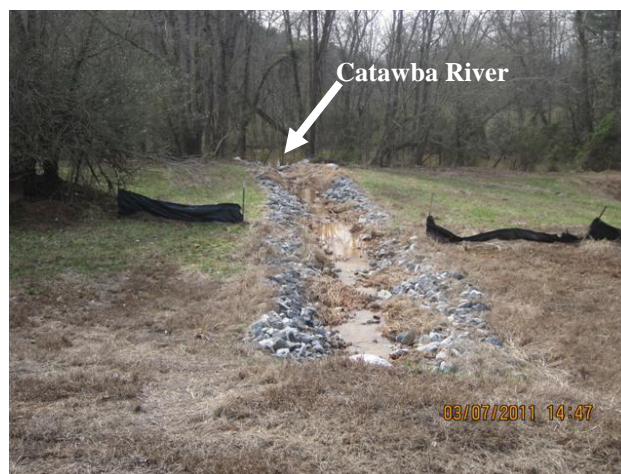
12. Looking (S) down the outflow channel from Sediment Basin SB-1 to the Catawba River in the background on 3/7/10.

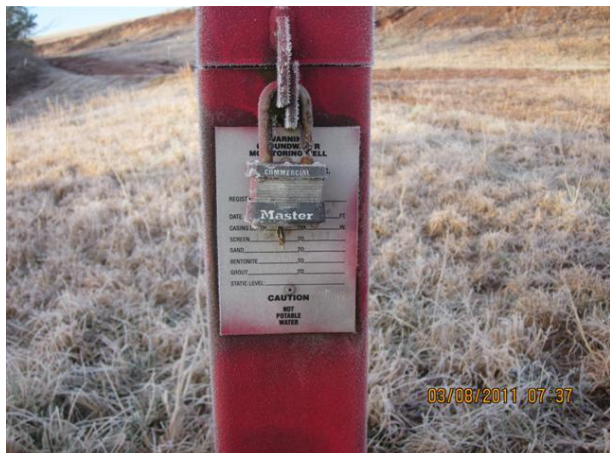
15. Several of the groundwater monitoring wells are not clearly marked with unique IDs. (Photo #13) **Please ensure that all groundwater monitoring wells are clearly marked with unique IDs.**

13. Groundwater monitoring well (believed to be MW-10) that is not clearly marked with a unique ID.

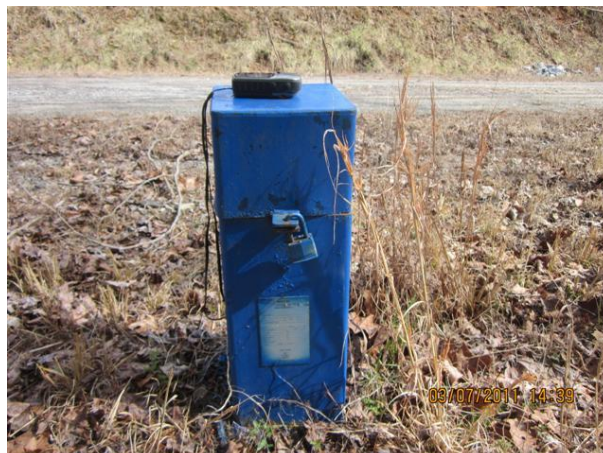
16. Landfill gas monitoring is conducted by JEI on a quarterly basis.
17. The most recent landfill gas monitoring event occurred on 11/30/10.
18. The landfill staff has painted the gas monitoring probes that are being monitored, blue. (Photo #14).

20. Several of the gas monitoring probes are not clearly marked with unique IDs. (Photo #14) **Please ensure that all gas monitoring probes are clearly marked with unique IDs.**

14. Landfill gas monitoring probe (believed to be GP-1) that is not clearly marked with a unique ID.
